February 2, 2022
Revised February 7, 2022

RE: **Engineering Services – un-permitted renovation**
LaBella Job: 2220691

As requested by you (Client, Owner), LaBella Associates visited the residential structure (subject structure) located at 83 King George Road in the City of Poughkeepsie, Dutchess County, New York (project site) on January 18, 2022.

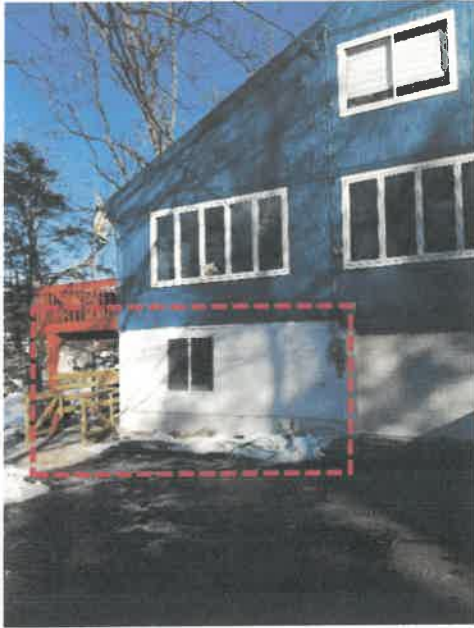
1. No permits were secured and therefore no AHJ code inspections were provided. Inspections by the AHJ are required as part of the permit process for nearly all aspects of the scope of work such as electrical, plumbing, HVAC, egress, life safety, building envelope and structural systems. Reference Appendix A for photographic log of observed conditions. Reference Photograph #1 for general view of subject structure.

Photograph (1): General view of subject structure.

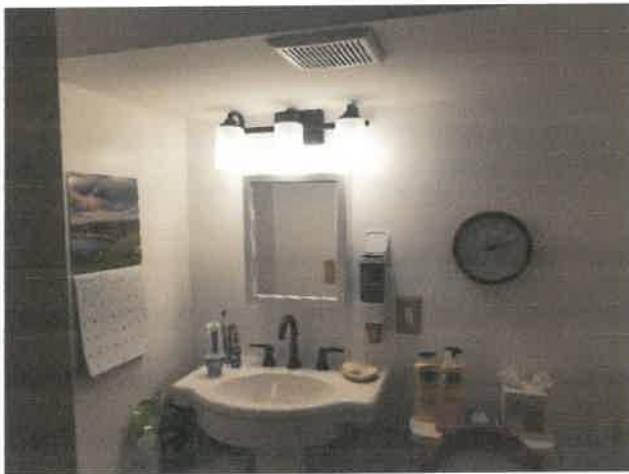
7. The renovated bathroom and new powder room utilize existing sanitary and plumbing service. Reference Photographs #2-4.
 - a. Existing sanitary system utilizes a sump and pump to push sanitary waste to municipal service at the street which is at a higher elevation utilizing 4-inch cast pipe. Reference Photograph #11.
 - b. New sanitary line was trenched into the slab for the new powder room, connecting to the existing system.
8. Bathroom exhaust fans appear to connect to the existing ductwork which may not satisfy the minimum ventilation requirements per the residential code. Reference Photograph #3.

Photograph (2): View of new powder room.

- f. Review bathroom exhausts and verify they exhaust directly to the building exterior (and not recirculating in the building by returning bathroom exhaust into the primary HVAC return air system. New exhaust ducts and outlets may be required.

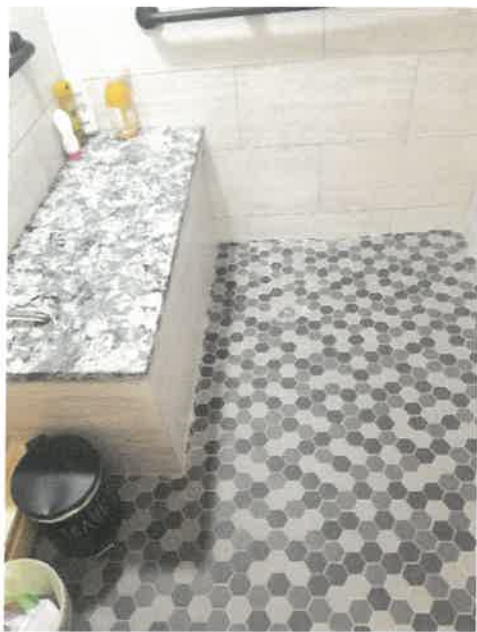
Photograph (3): View of renovated bathroom.

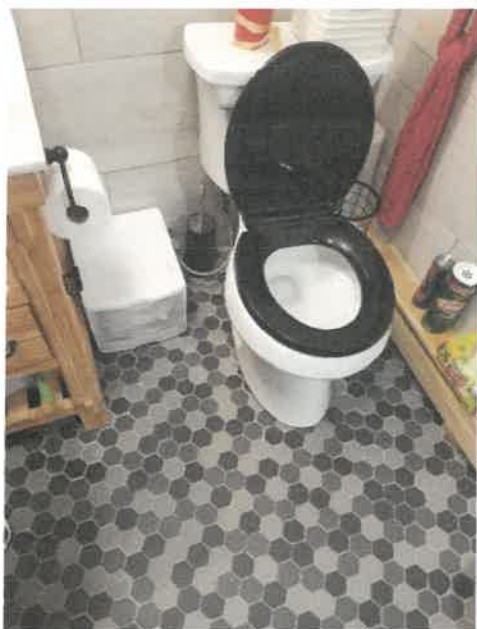
Photograph (4): View of renovated bathroom.

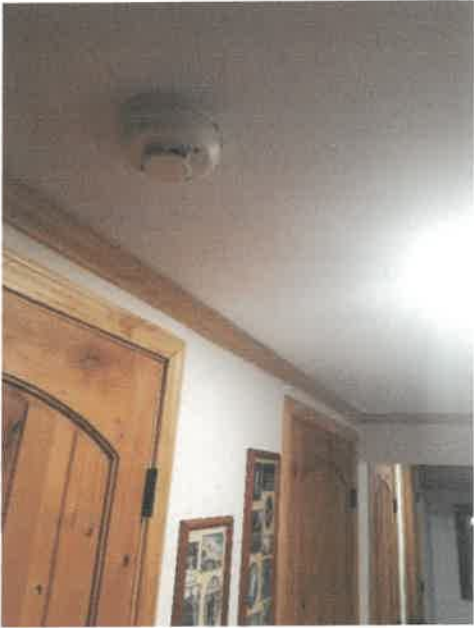
2. No functioning smoke or carbon monoxide alarms were installed as part of the renovation. These life-saving devices are a critical element of the life safety system.

Photograph (5): non-working smoke detector outside of utility room.

1. Install combination smoke / CO detectors as follows (and as recommended in email correspondence dated January 19, 2022):
 - a. In the hallway between the furnace room and bathroom (within 3' of the bathroom).
 - b. In the bedroom within 3' of the bathroom.
 - c. Outside (but close to) the bedroom. The code would typically not require one in the kitchen (as it would alarm too often), but since the bedroom opens directly to the kitchen, one is needed.
2. We recommend contacting the local AHJ to review the site and our letter and to discuss potential next steps. The AHJ may require specific systems be exposed and or tested as part

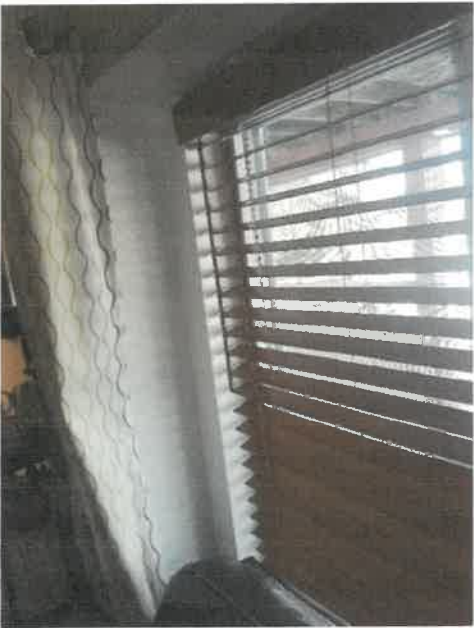
12. Egress windows are provided in the bedroom and office area.
13. No observable code violations beyond the smoke / CO detection noted elsewhere.

Photograph (6): New egress windows in bedroom and office.

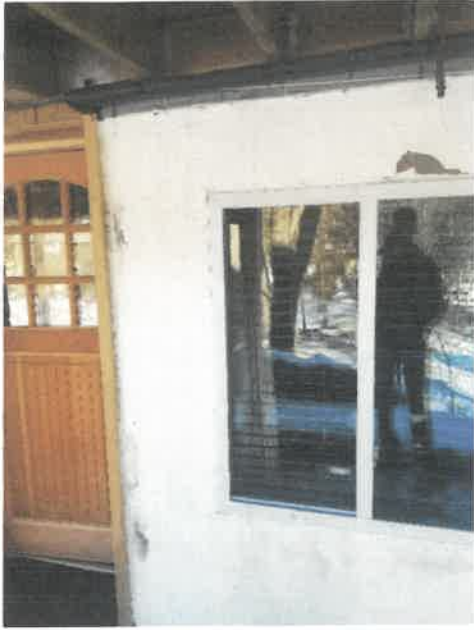
4. No exterior lighting has been provided as part of this renovation.
5. Perimeter doors and windows appear to generally align with existing openings. However, it seems the new door may have been cut into the load bearing wall. It is not clear that proper structural support has been provided including a header and jack system to support the floor joists and wall above.

Photograph (7): New window in existing opening, new door in new opening.

- a. While not a code requirement, we recommend installing exterior path lighting.
- b. Provide a probe in the ceiling in front of the door to verify that a properly sized header has been installed per code.

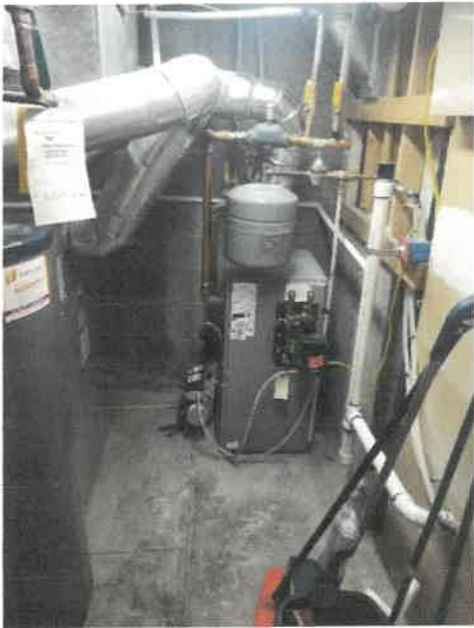
6. A new oil-fired furnace was added in the utility room with all new hydronic piping and wood diffusers throughout providing primary heat to the unit. Secondary heat is provided by the original forced-air furnace located in the same utility room which provides heat to the primary residence above. Reference Photograph #8.

- a. The new furnace exhaust ties into an existing flue and chimney at the rear of the subject structure.
 - b. Makeup air appears to be provided to the utility room with louvers connected to the hallway which were covered with photograph frames. Fresh makeup air does not appear to be provided.

Photograph (8): New hydronic gas-fired furnace.

- c. Retain a qualified HVAC contractor to review the furnace installation for code compliance, specifically makeup air. The contractor should furnish a letter of compliance as part of their deliverable.

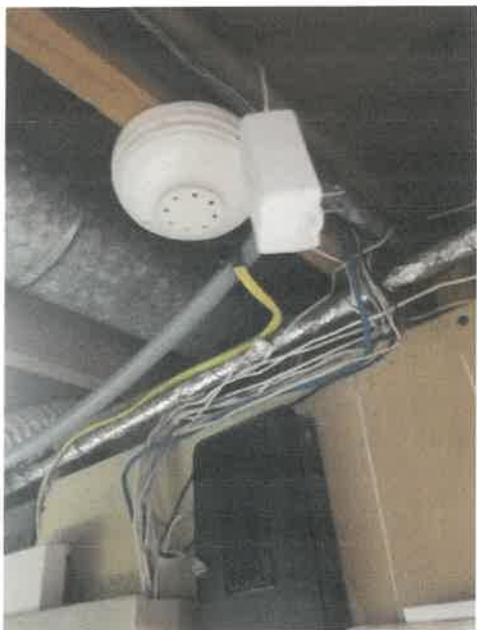
- d. Heat detection is provided in the utility room, but was not tested. The wiring appears to be repaired or spliced with electrical tape and is unsupported in some areas. Reference Photograph #9 and 10.

Photograph (9): Smoke detection in utility room with electrical tape splice.

- d. Move the gas disconnect switch to the hallway.
- e. Remove spliced wire at utility room smoke detector and replace with continuous and supported wire per code.

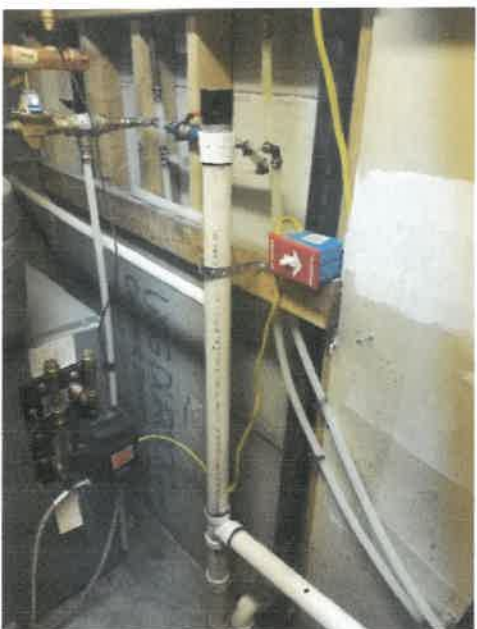
- c. A gas disconnect switch is located within the utility room with unsupported NM wires. Reference Photograph #10.
 - i. Disconnect switches should be located outside of utility rooms and NM wiring should be supported.

- e. An air admittance valve for the renovated bathroom is located in the utility room.

Photograph (10): Gas shut off switch inside of utility room. Unsupported NM wire. Air admittance value behind renovated bathroom.

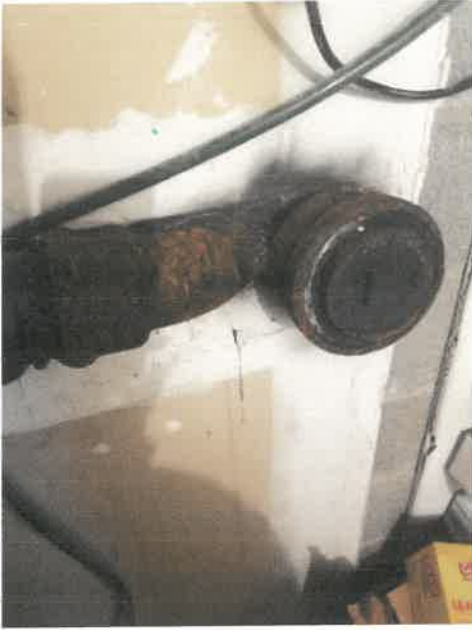
Photograph (11): Existing 4" force main sanitary line

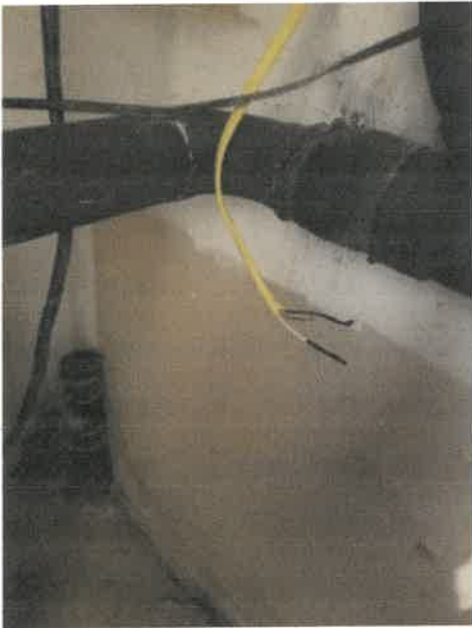
9. Exposed / unsupported wires were observed in the pump room.
 - a. It seems the yellow wire may be disconnected at the panel but is not labeled and unsupported with exposed ends. The black wire is for the new 220V outlet for the laundry room and is also unsupported.
 - b. The wires extend to the main service panel in the garage. Reference Photograph #13.

Photograph (12): Exposed / unsupported wires.

- g. Support NM wires within the pump room and garage.
- h. Remove decommissioned wire or properly terminate ends within junction boxes.
- i. Repair damaged breaker panel.

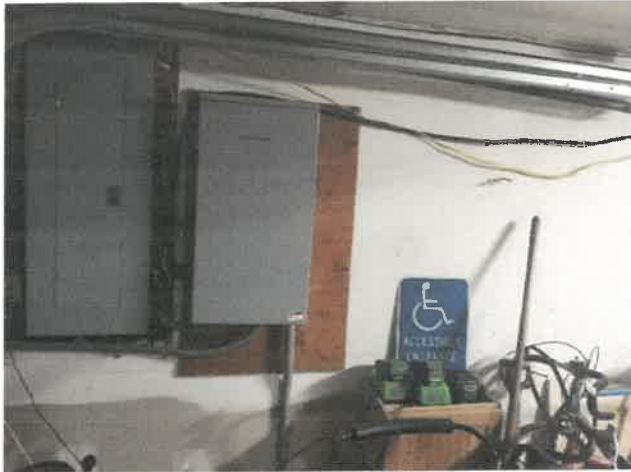
Photograph (13): Unsupported nm wires.

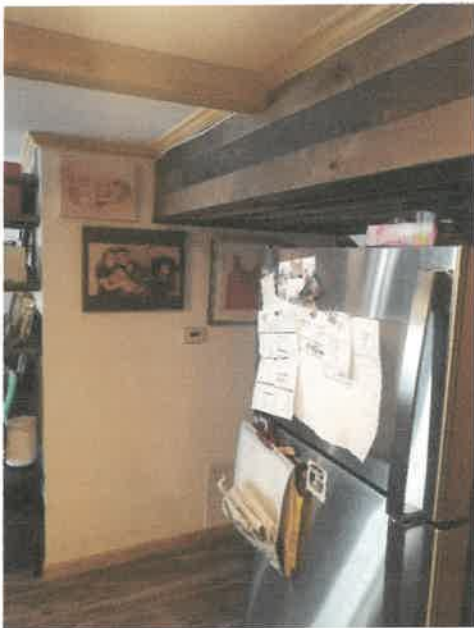
3. There is a low headroom condition in the hallway. However, it appears this is an existing condition and not related to this renovation. The low headroom is due to ductwork from the existing HVAC system which has been enclosed in wood trim. The reduction in headroom due to the wood trim is inconsequential.

Photograph (14): Low headroom – existing condition.
